W. W. Hansen Experimental Physics Laboratory  
STANFORD UNIVERSITY  
STANFORD, CALIFORNIA 94305-4085  
GRAVITY PROBE B RELATIVITY MISSION

## GMA VALVE LEAKAGE MITIGATION PLAN

S0701 Rev B

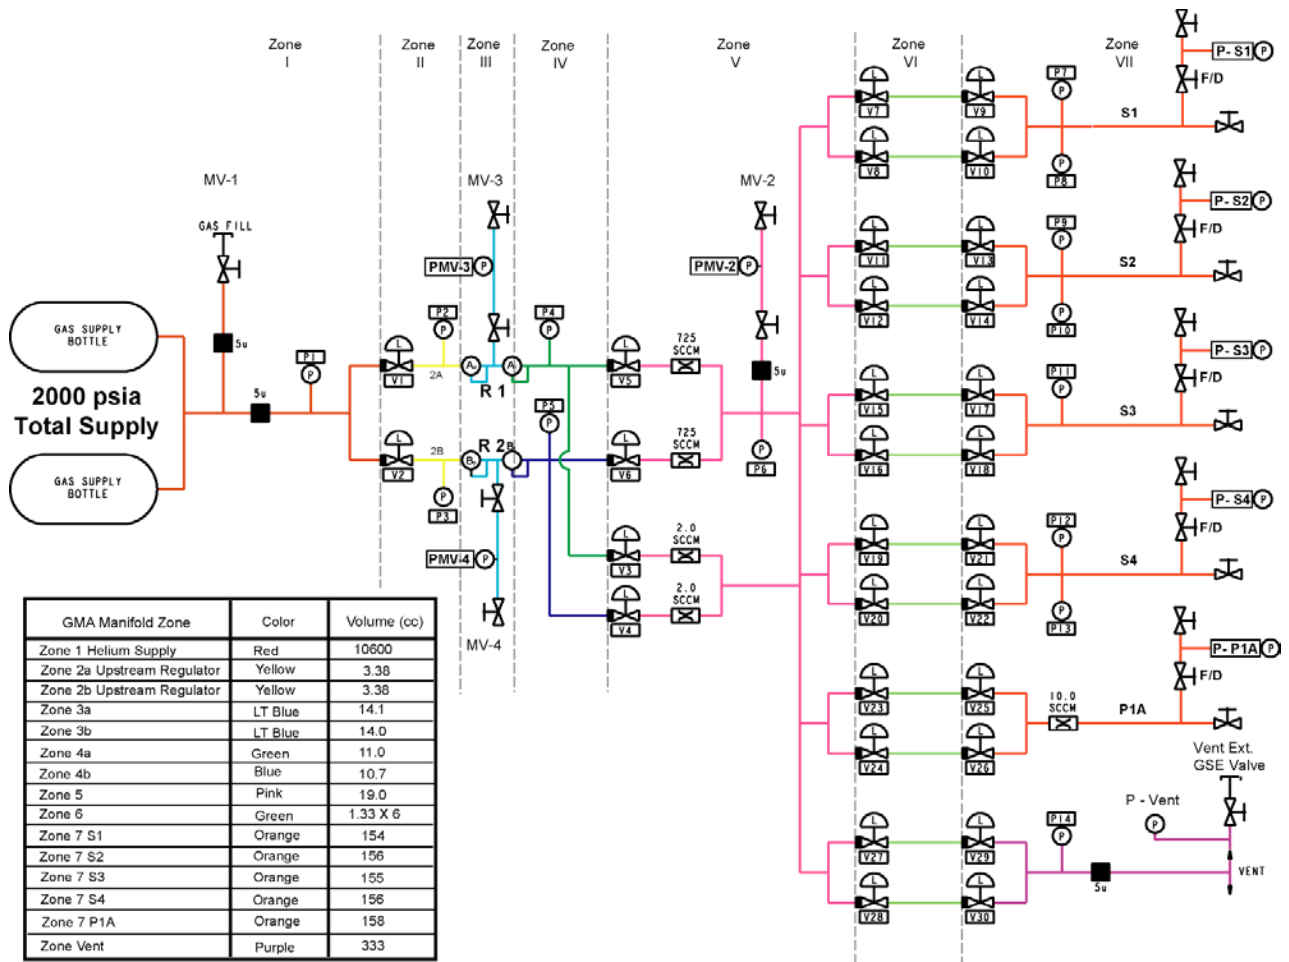
Figure 1

Rate of Rise data is monitored using pressure transducers in all GMA zones except zones 4 and 6. (See schematic figure 1).

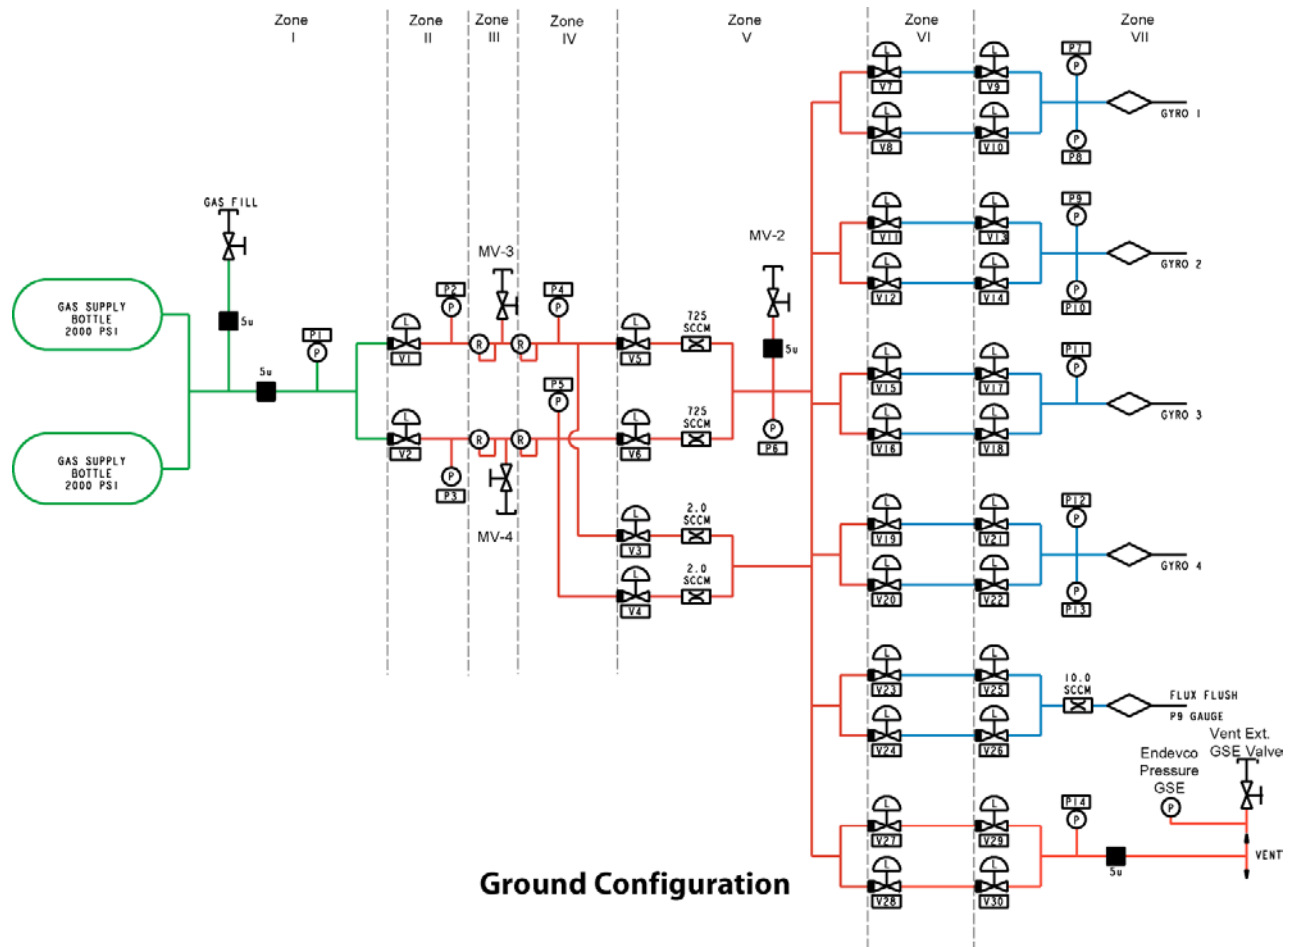
Figure 4

Ground configuration (figure 4) has all the latch valves closed except the vent quad. A ground configuration for the latch valves is necessary prior to opening the Gas Inlet Manual Valves at the top hat. This starts to minimize gas leaking into the probe inlets. Ground configuration also has 300 psia in the manifold in zones 2, 3, 4, 5 and the vent as shown in RED in figure 4. This supports regulator lock-up and protects the GMA from potential air contamination through the vent outlet.

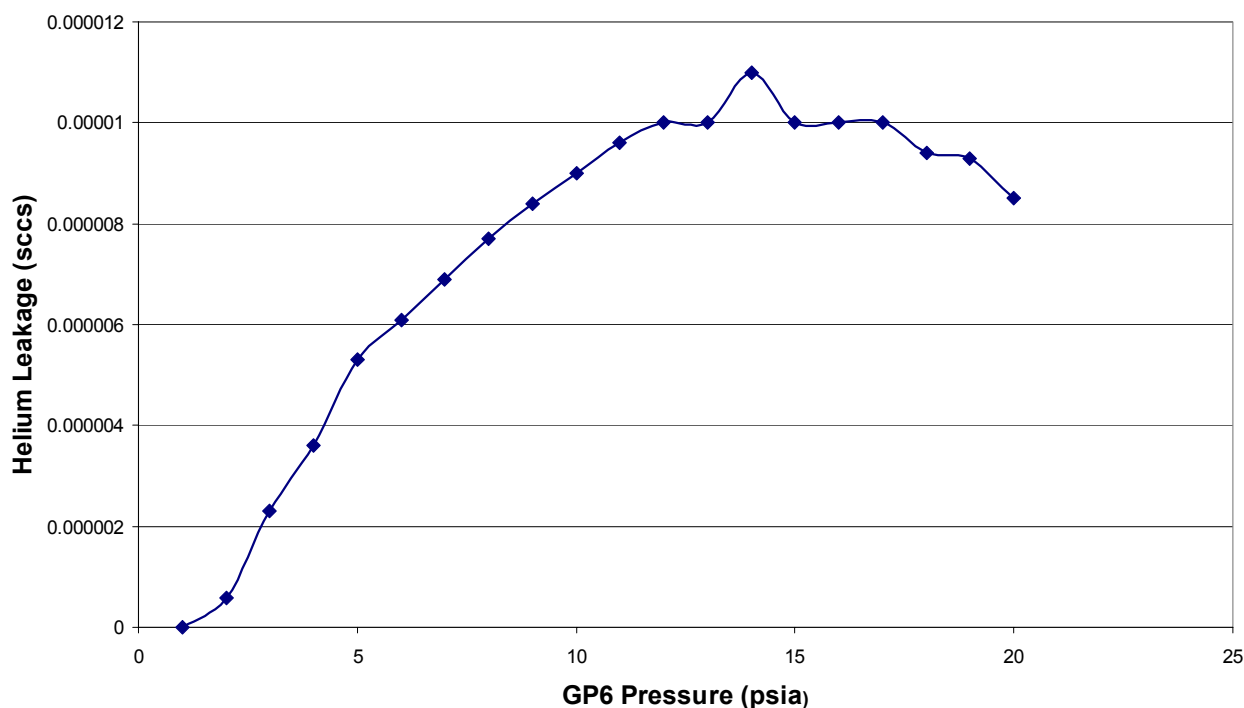
**GMA System Internal Leakage in Flight Configuration**  
As Tested 7/30/02 at Moog Inc. per AVO50E961RA16

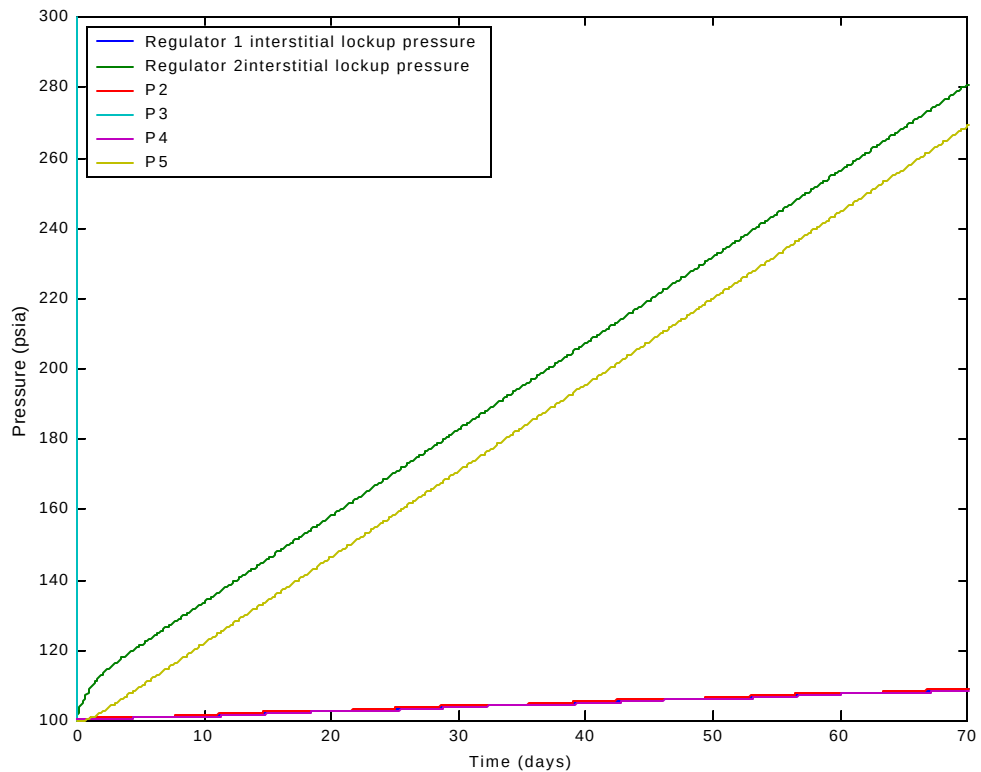
- corrective action: significant servicing of GMA and testing of Probe may be required (this failure should be prevented, recovery would be very difficult)

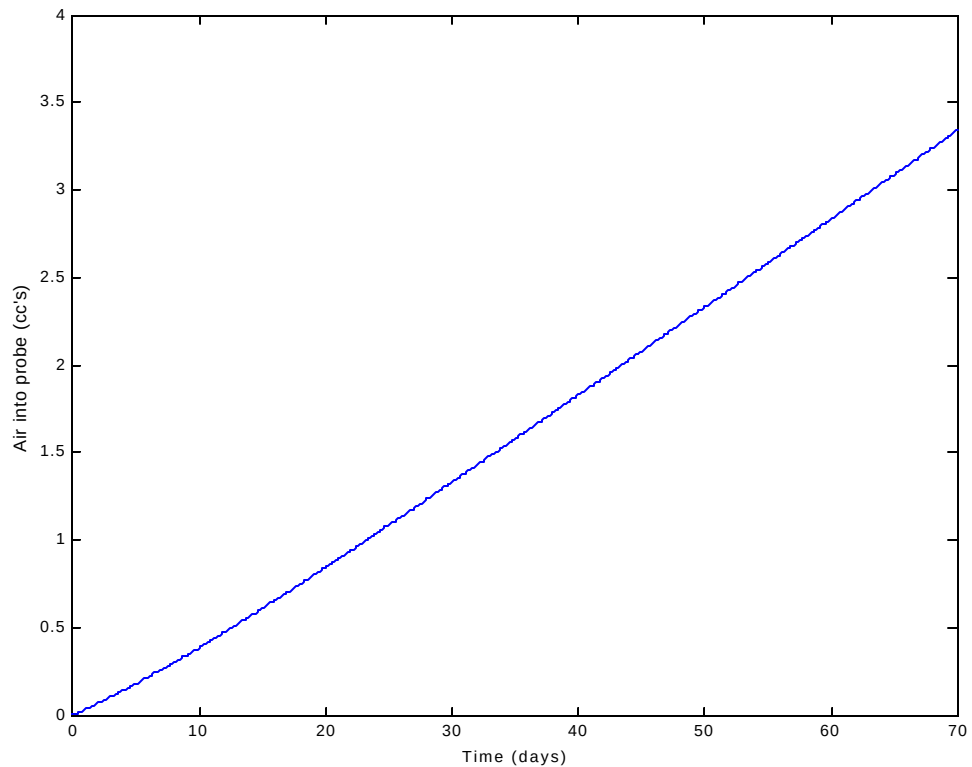
Some of the hold times listed above are cumulative – if 20% of the ground state hold time is consumed, then 20% of the launch state hold time may also have been consumed.

It is necessary to understand that the pre-launch sequence of activities will effect some of the maintained pressures in the following ways:

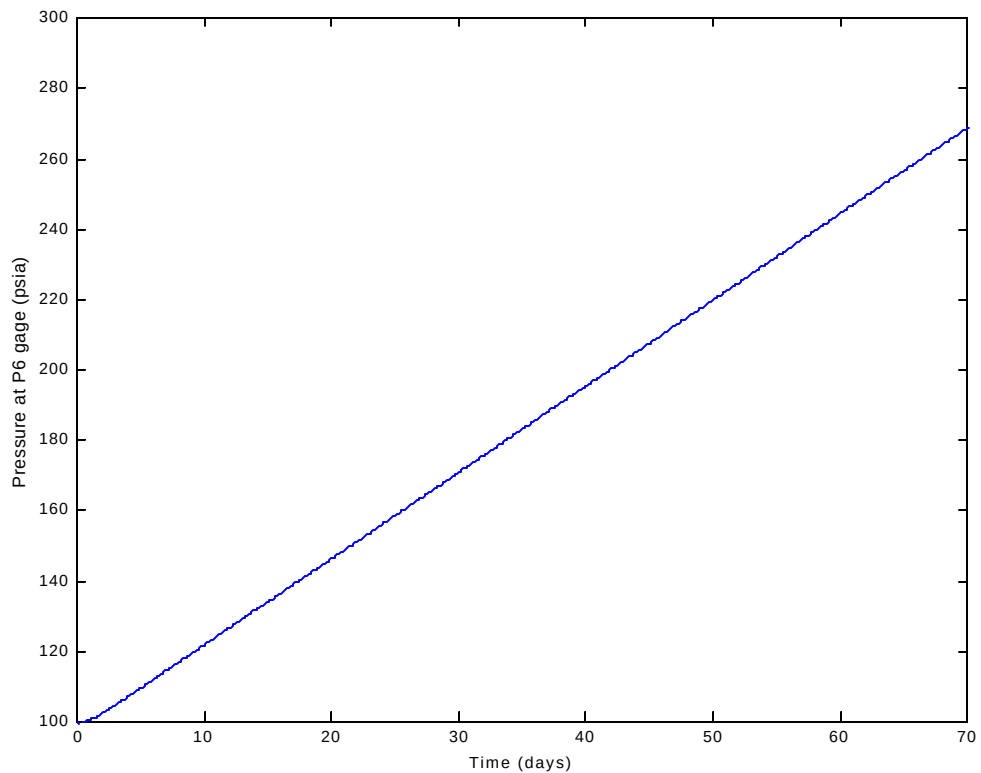
### C.3.6 Conclusions

“Very Low” indicates hold times greater than 300 days *or* extremely low risk of harmful effect
