Gravity Probe B Relativity Mission

**Closure of Probe  
Contamination Discrepancy Reports**

S0582 Rev. -

# **Appendix A** **Investigation of Particulate Contamination** **in the Gravity Probe B Low Temperature Probe C**

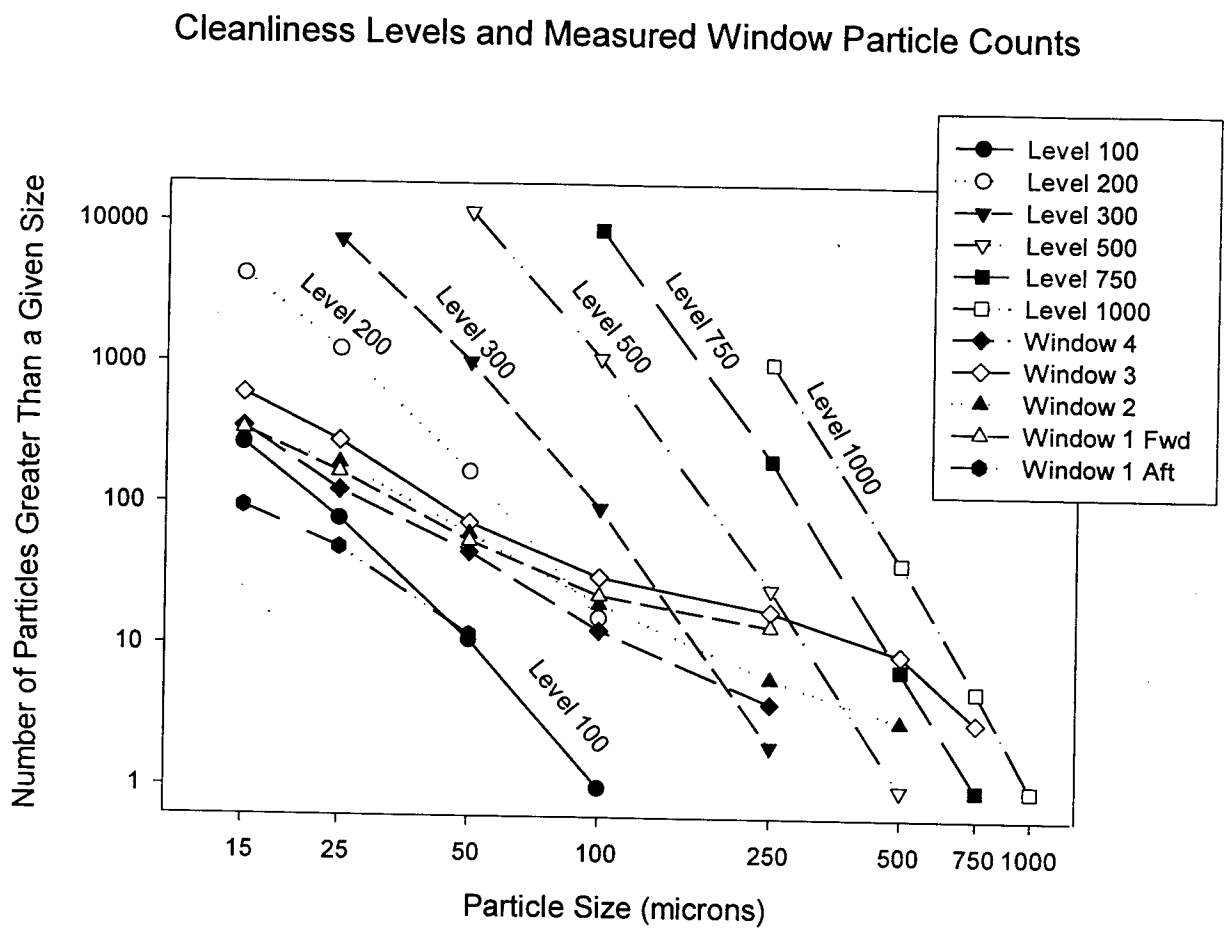
Figure 1. Cleanliness Levels and Measured Window Particle Counts.

These particle counts may be compared with the particle counts specified for different cleanliness levels by MIL STD 1246 C. Figure 1 shows the distribution of the particles on each of the windows compared to the specifications for each of the levels. It is interesting to note that the distribution of the particles on the windows is has a small number of large particles. Except for this small number of large particles the surface cleanliness levels meet level 200 standard. Also note that the surface closest to the probe meets the level 100 standard.

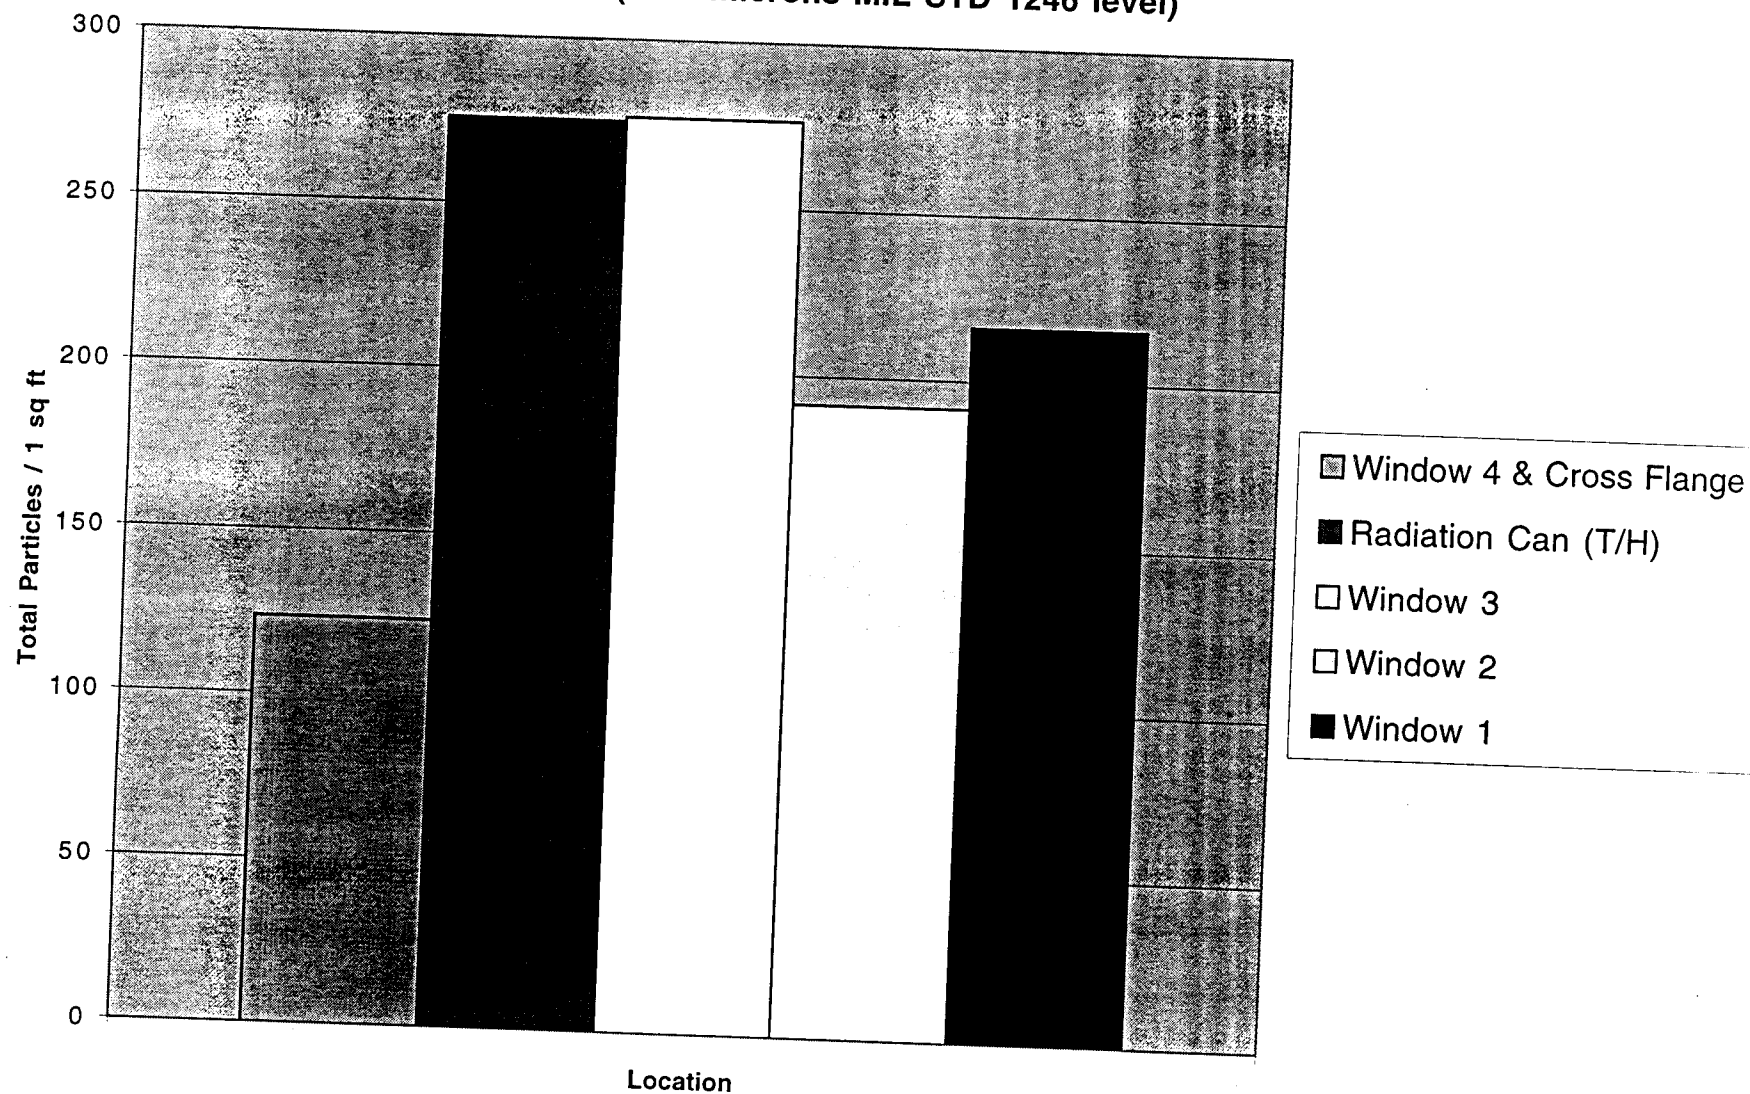
**Probe C Windows Contamination**  
(> 25 microns MIL STD 1246 level)

Photomicrographs showing the varied shape and morphology of typical debris found on the windows are shown in Figure 1. Visual examination showed that window #4 contained the most debris, window #3 showed comparatively less, and window #2 had the least amount of debris. Table 2 contains the final particle counts from each location within the Probe. The results were normalized from their total surface area to 1 square foot to allow relative comparisons to each other and to MIL-STD-1246 levels. Table 2 also contains a chart to graphically illustrate the relative contamination levels.

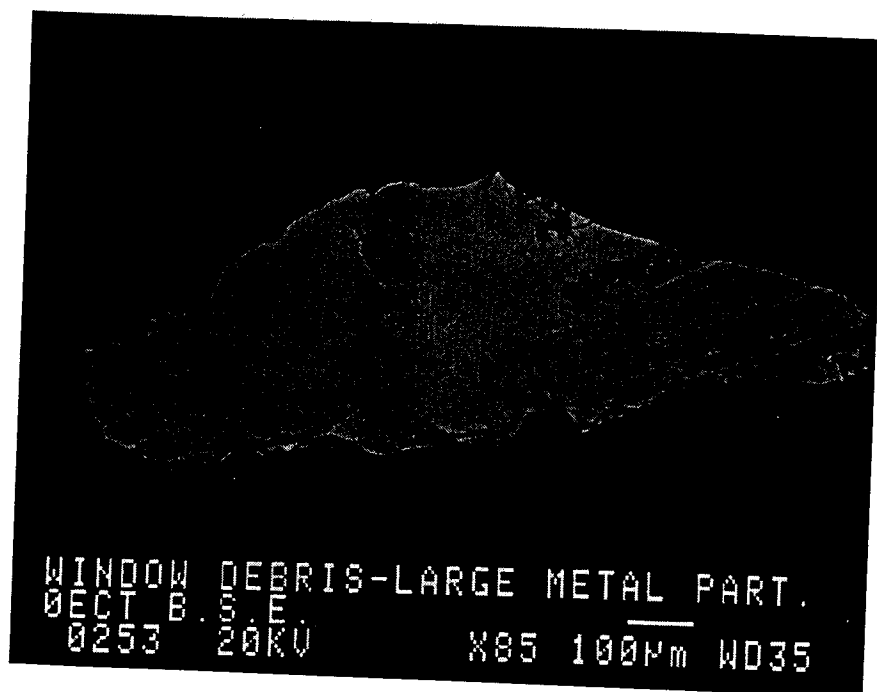
Figure 7. SEM Photomicrograph of a one-mm long particle (3) located in window 4 that contains nickel and phosphorus with dark regions of aluminum.

Particle 3 was the largest debris particle found and measured one mm in length as shown in the photomicrograph in Figure 7. It consisted of nickel and phosphorus (possibly from an electro-less nickel-plating operation) and the dark spot was rich in aluminum. There is some concern for the nickel-based materials found (particles 3 and N), since nickel can be ferromagnetic. Suggestion was made that the particles be tested to evaluate their magnetic behavior.

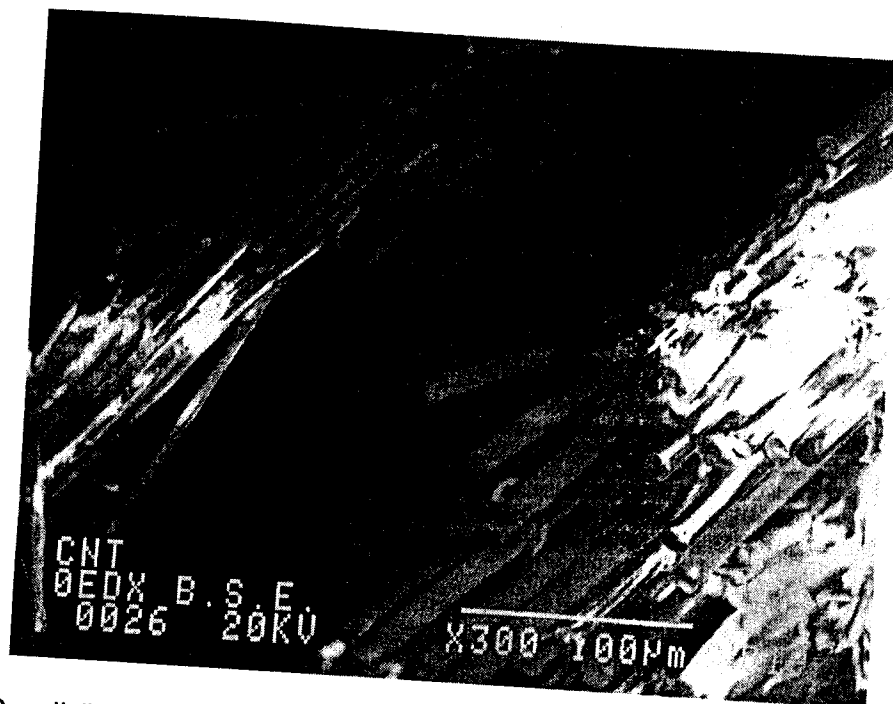
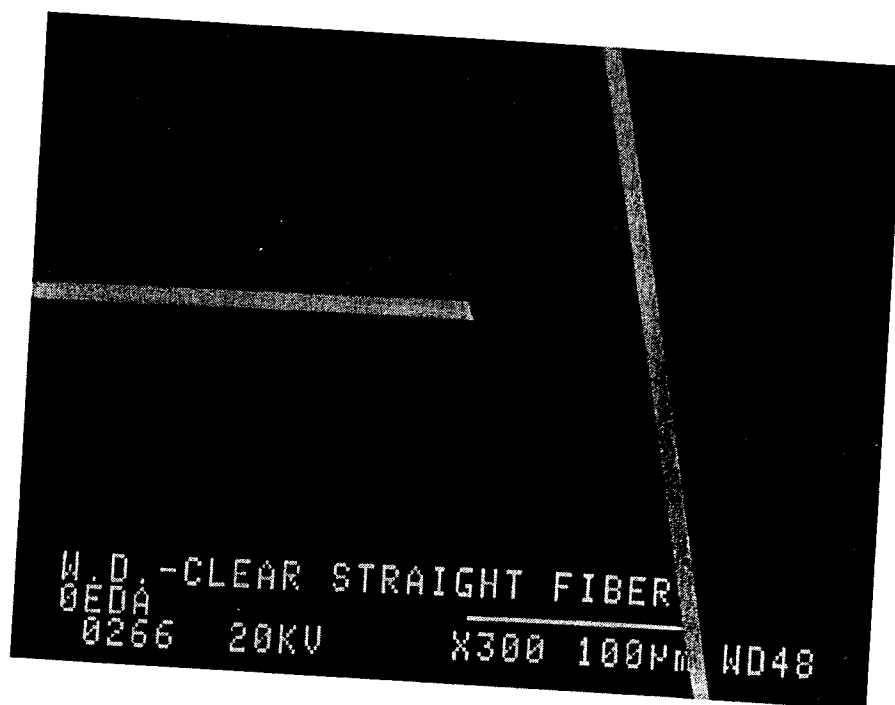
Figure 9. SEM Photomicrographs at 300X magnification showing relative fiber diameter differences between the CNT fibers and fiber M.

The straight, clear fiber M (301) was identified as a glass, containing oxygen, silicon, aluminum, calcium, and small amounts of magnesium and sodium. These elements are probably in the form of a complex oxide, which is typical for a glass. Representative cured CNT material, which contains reinforcing glass fibers, was examined for comparison to these glassy fibers. It was found that the known CNT material contained two different diameter fibers, and their chemistry varied a little, but both contained alumina and silica. Their FT-IR spectra and that of fiber M are shown in Figure 8. The FT-IR results show the small (340) and large (338) diameter fibers differ from one another, but that fiber M is very similar to that of the small diameter fiber. Photomicrographs of these three fibers are shown in Figure 9 and relative fiber thickness measurements were made at 300X magnification. The larger diameter fiber in the CNT was 0.1560", fiber M was 0.1030" and the smaller diameter CNT fiber was 0.061". EDS elemental analysis is compared in Figure 10.

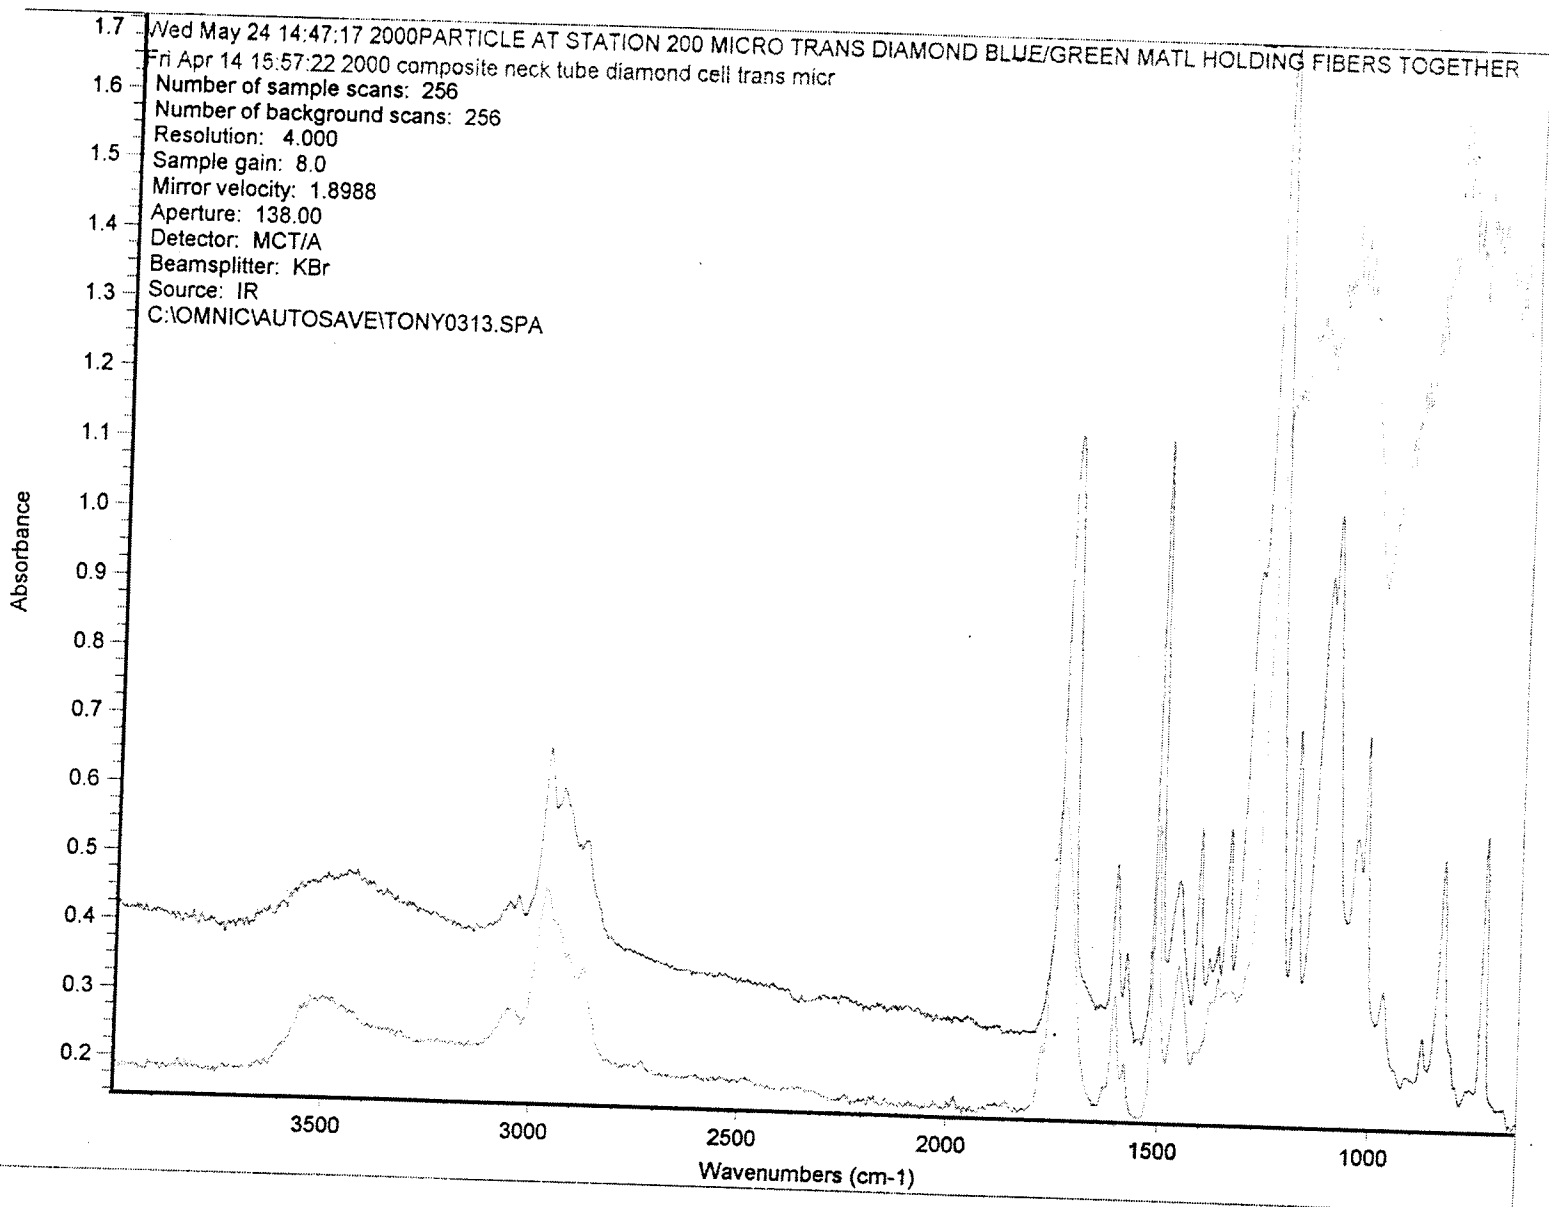
Figure 14. FT-IR Spectra for particle at Station 200 and binder of the CNT epoxy is compared.

Particles in V3 (266) and the "blue-fibrous debris mass" removed from Station 200 below window 1 (313) were identified as epoxies. FT-IR comparison showed they were not identical to one another. However, each was then compared to the three known epoxies in the CNT area—binder in the CNT, blue death epoxy, and FM-73. V3 (266) had similar general characteristics of FM-73 as shown in Figure 13. The epoxy found at Station 200 compared very well to that of the CNT binder material as shown in Figure 14.

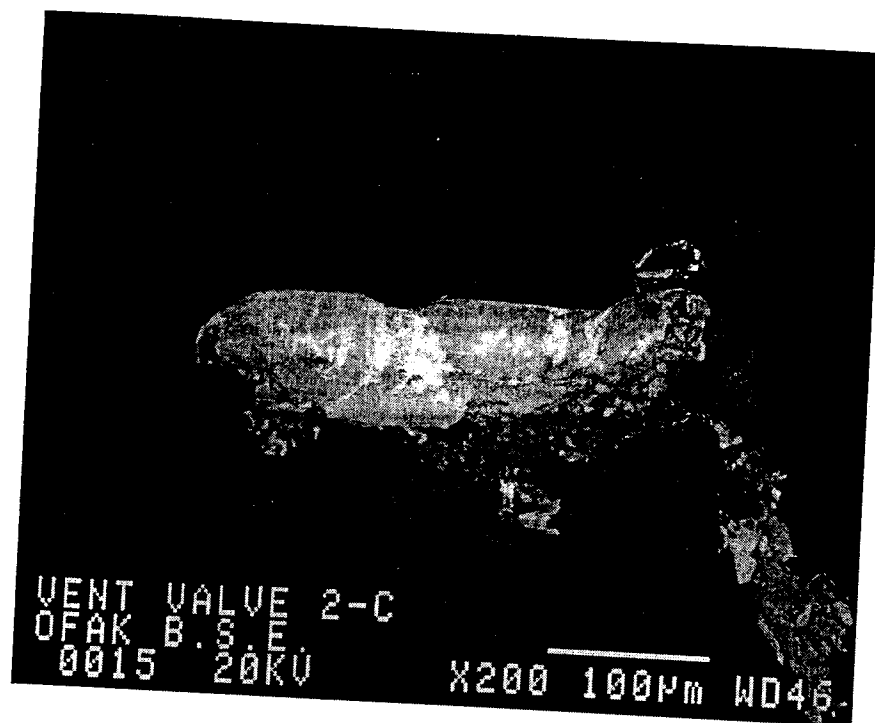
Figure 15. Vent valve 2C (V2C) yellow particle that contained copper and zinc (brass) and had contaminants of lead and cadmium on it.
