W. W. Hansen Experimental Physics Laboratory  
STANFORD UNIVERSITY  
STANFORD, CALIFORNIA 94305-4085  
GRAVITY PROBE B RELATIVITY MISSION

## GMA VALVE LEAKAGE MITIGATION PLAN

S0701 Rev B

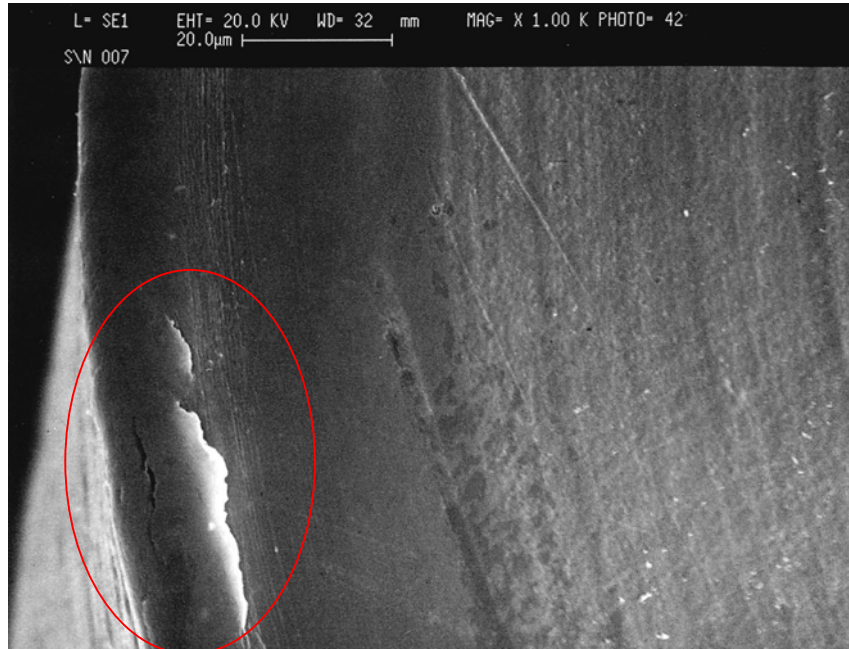
51E265 SN007 Poppet sealing surface viewed with Lockheed Martin SEM. Note burr near sealing edge.
