Gravity Probe B Relativity Mission

**Closure of Probe  
Contamination Discrepancy Reports**

S0582 Rev. -

# **Appendix A** **Investigation of Particulate Contamination** **in the Gravity Probe B Low Temperature Probe C**

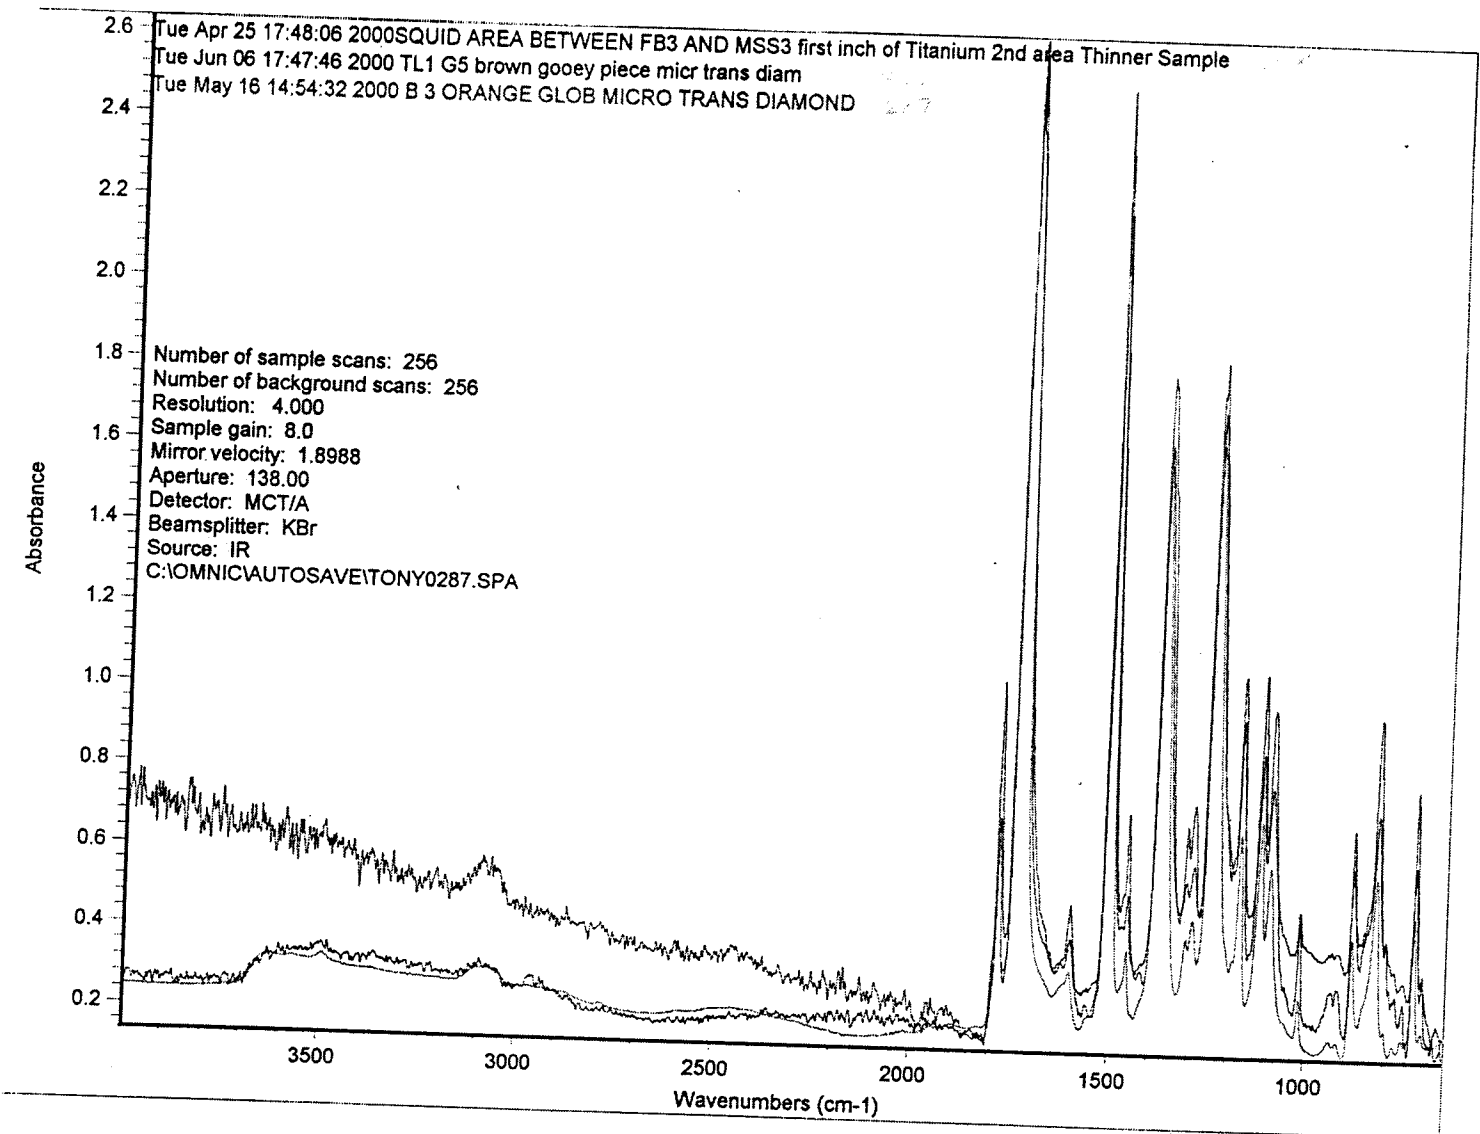
Several FT-IR spectra having file numbers of 258, 287, and 325 were identified as poly(amide-imide) and the super-imposed spectra are shown in Figure 2. FT-IR spectrum 258 was a large particle found on the squid area between FB3 and MSS3, spectrum 287 was particle B from

Figure 2. FT-IR Spectra for three particles identified as poly(amide-imide).

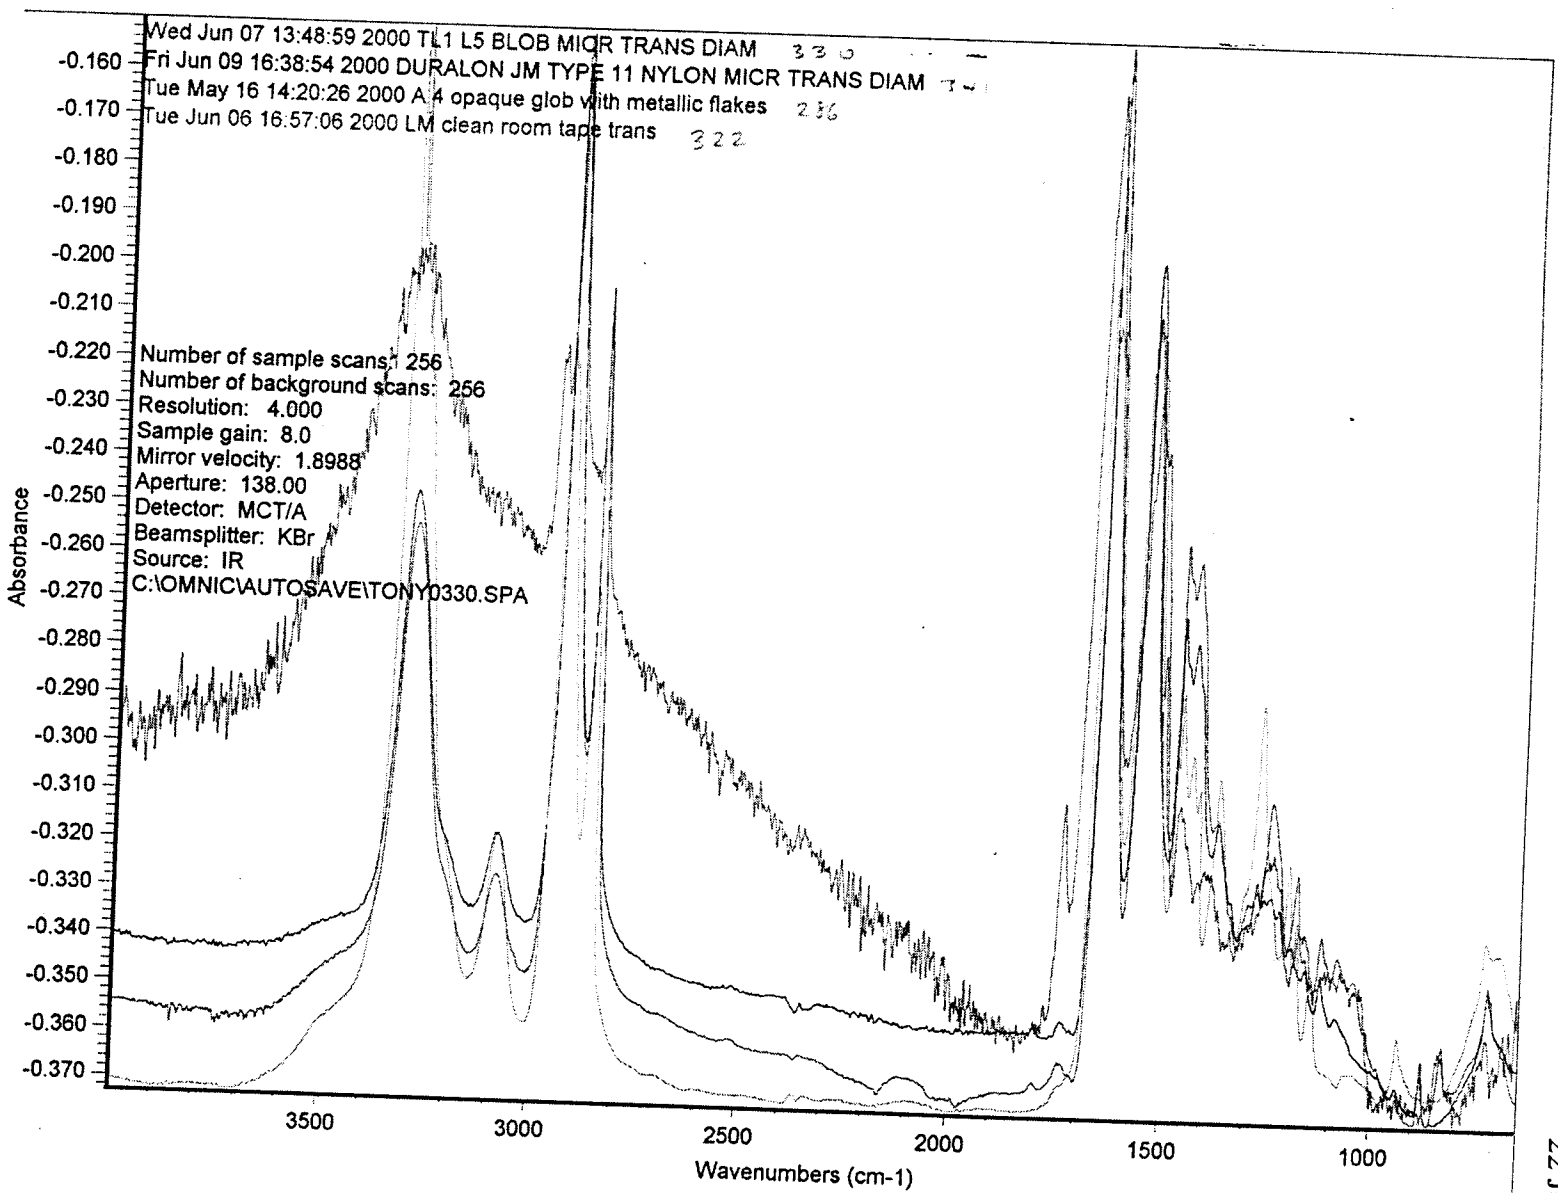
Three debris particles were identified as polyamide, or nylon-type, materials. These particles are: particle A (286), which was found on window 4; TL1 L5 (330); and the greenish colored particles on the probe exterior along the cross-flange (341). Figure 3 shows these three superimposed spectra with the LM white clean-room tape (322) that was identified as nylon. While TL1 L5 particles found on the cross-flange are highly suspected to be the Duralon JM Type 11 nylon, it should not be interpreted that the other three nylon scans are this brand or type of nylon. It is not easy to distinguish between the various "types" of nylon by FTIR (for example, nylon 6, 66 or 11).

Figure 3. FT-IR Spectra for three particles and a known clean-room tape that were identified as polyamide or nylon.

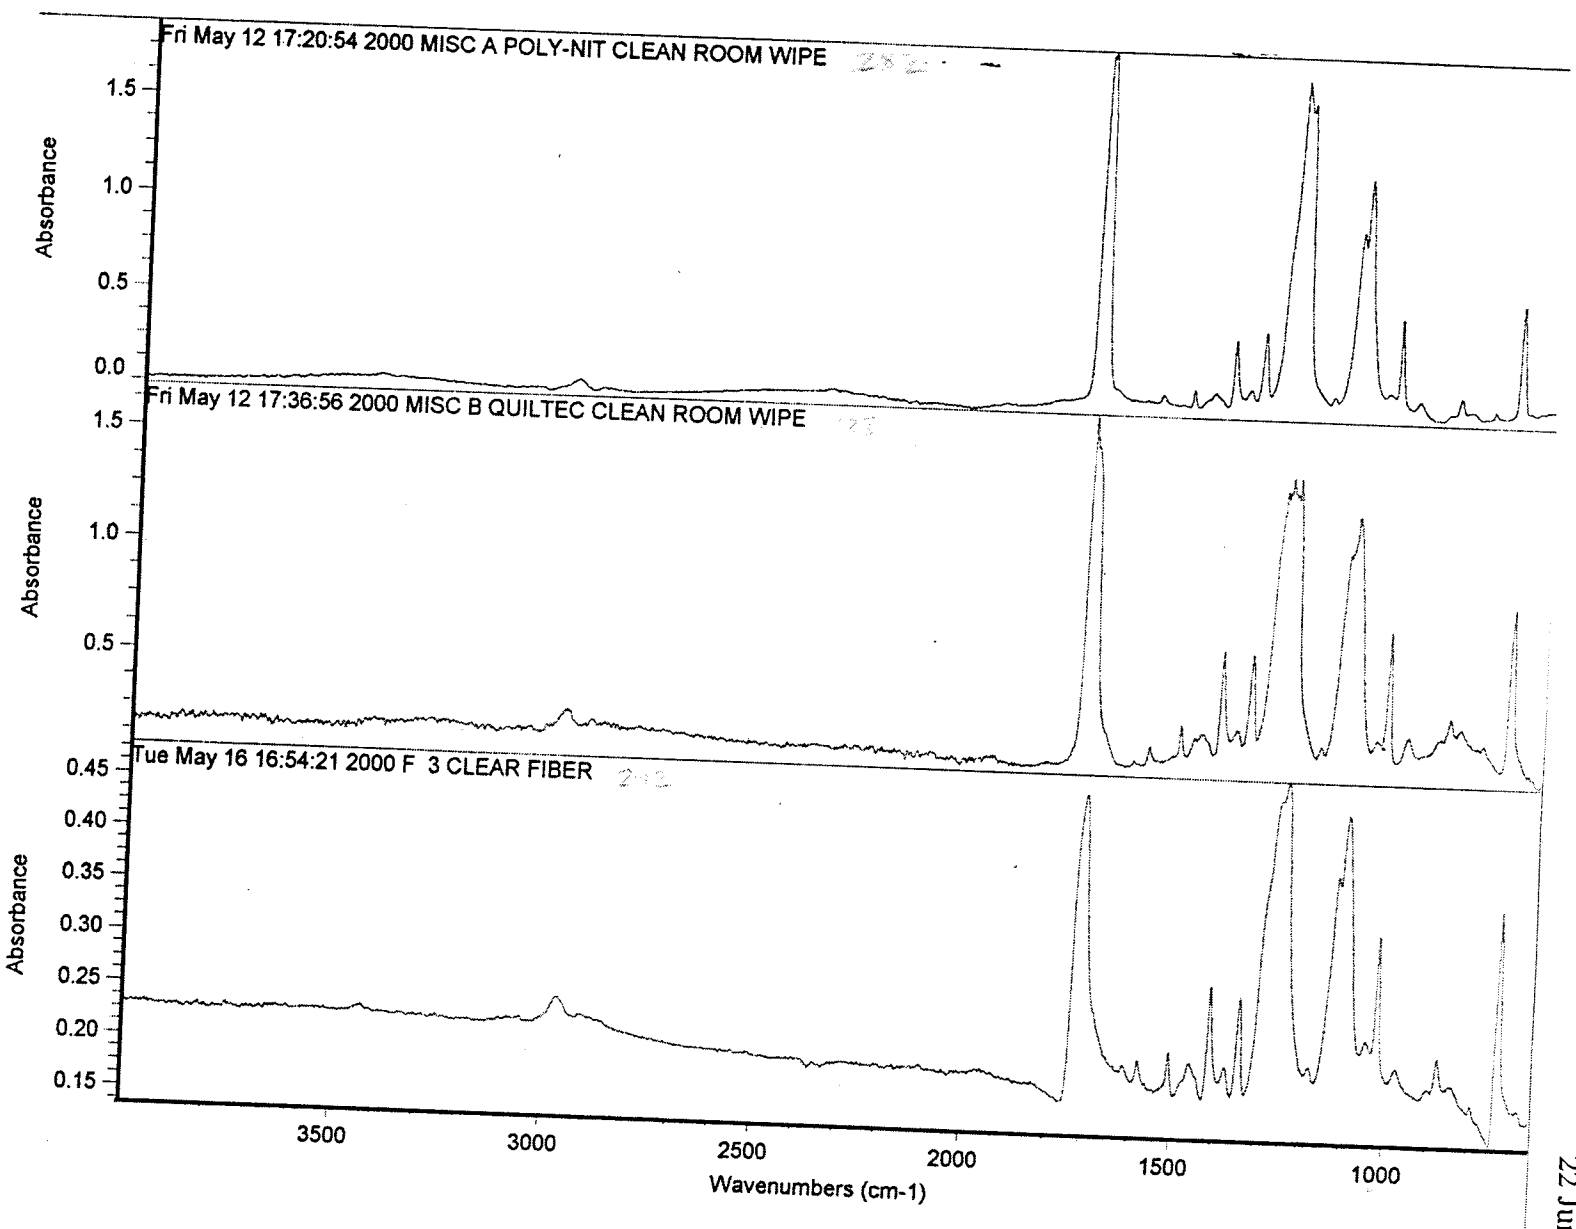
The clear, curly-shaped fiber F (292) was identified as a PET polyester and FT-IR spectra showed similarity of F to the spectra of Misc A (282) and Misc B (283) wiper fibers (also identified as PET). This comparison is shown in Figure 4. The F fiber could be from a PET polyester wiper but no definitive comparison could be made to determine that it was from the Stanford clean-room Contec-brand polyester wipers.

Figure 4. FT-IR Spectra for fiber F and two known clean-room wipers that were identified as PET polyester.

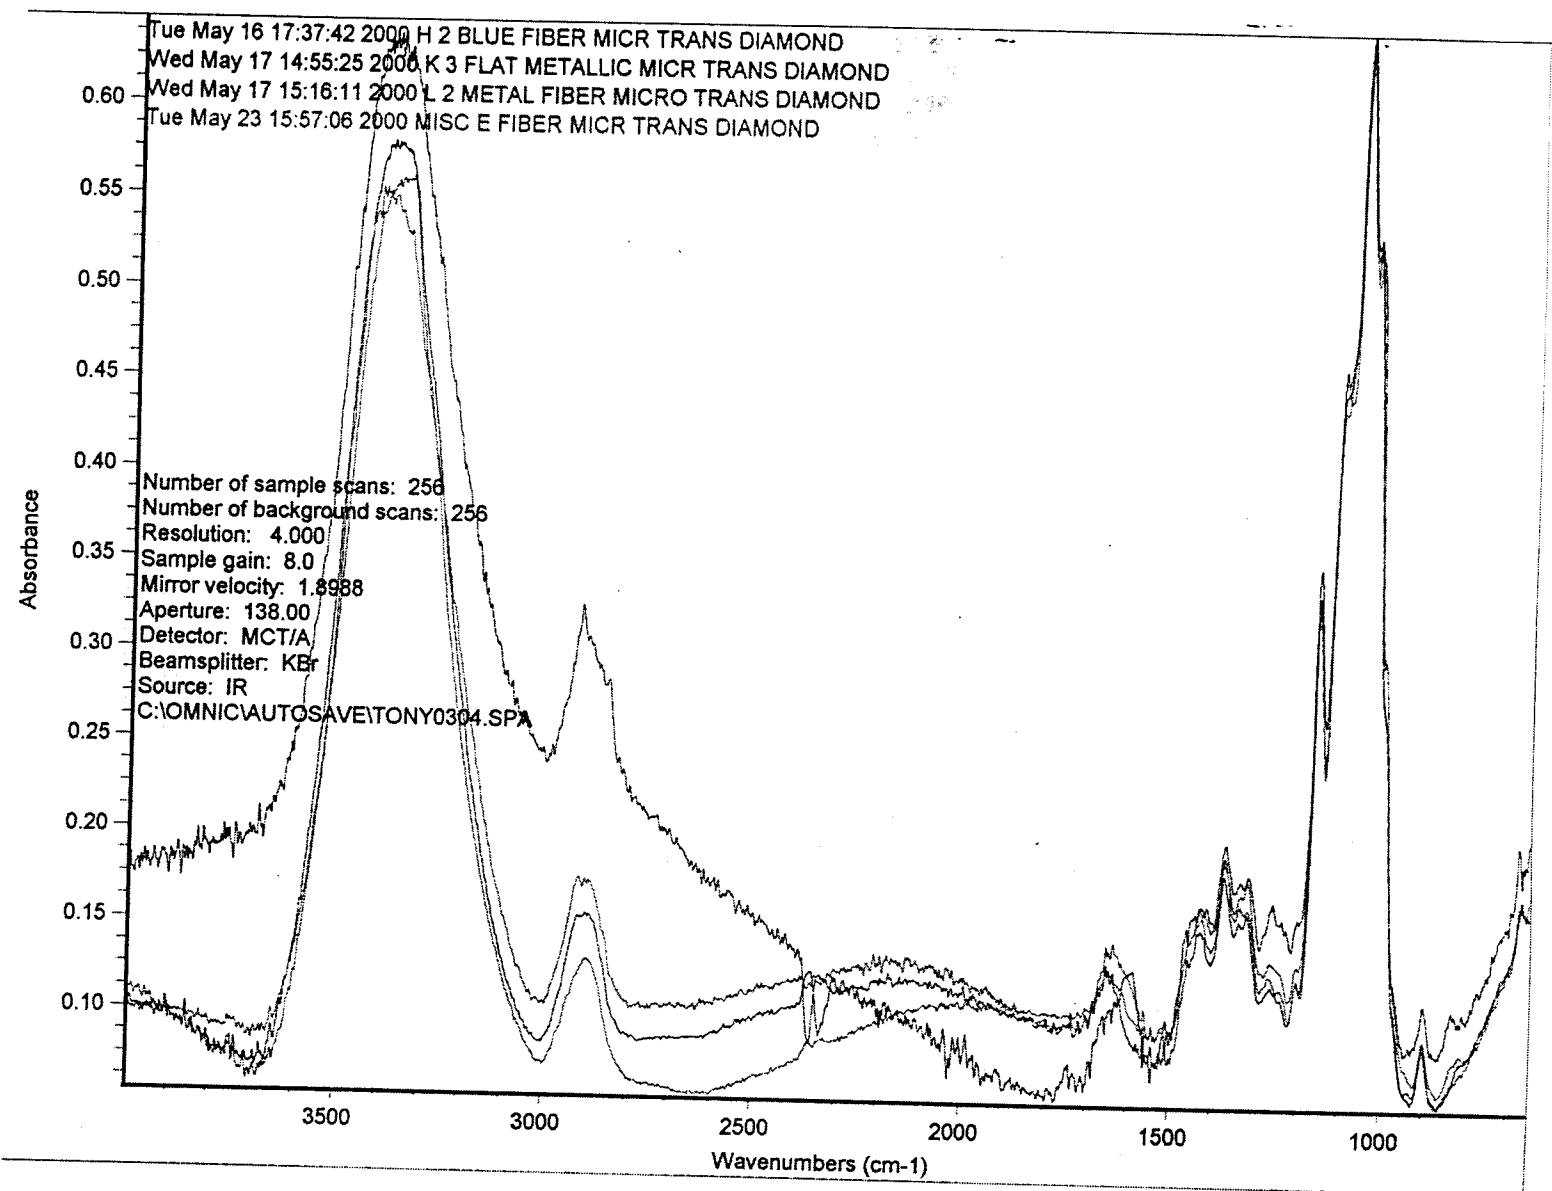
Fiber H (FT-IR file #293) and particles K (297) and L (298) were all identified as cellulose material. Debris H and L were located on window 2 and debris K on window 3. The FT-IR spectral lines of H, K, and L are very similar to that of Misc. E, a Texwipe, clean-room wiper (304) as shown in Figure 5. None of these are similar to the Millipore filter (294), which has cellulose nitrate peaks at 840, 1300, and 1665  $\text{cm}^{-1}$  and an ester peak at 1750  $\text{cm}^{-1}$ .

Figure 5. FT-IR Spectra for three particles located on windows 2 (H and L) or 3 (K) and a clean-room Texwipe wiper (Misc E) that were identified as cellulose.

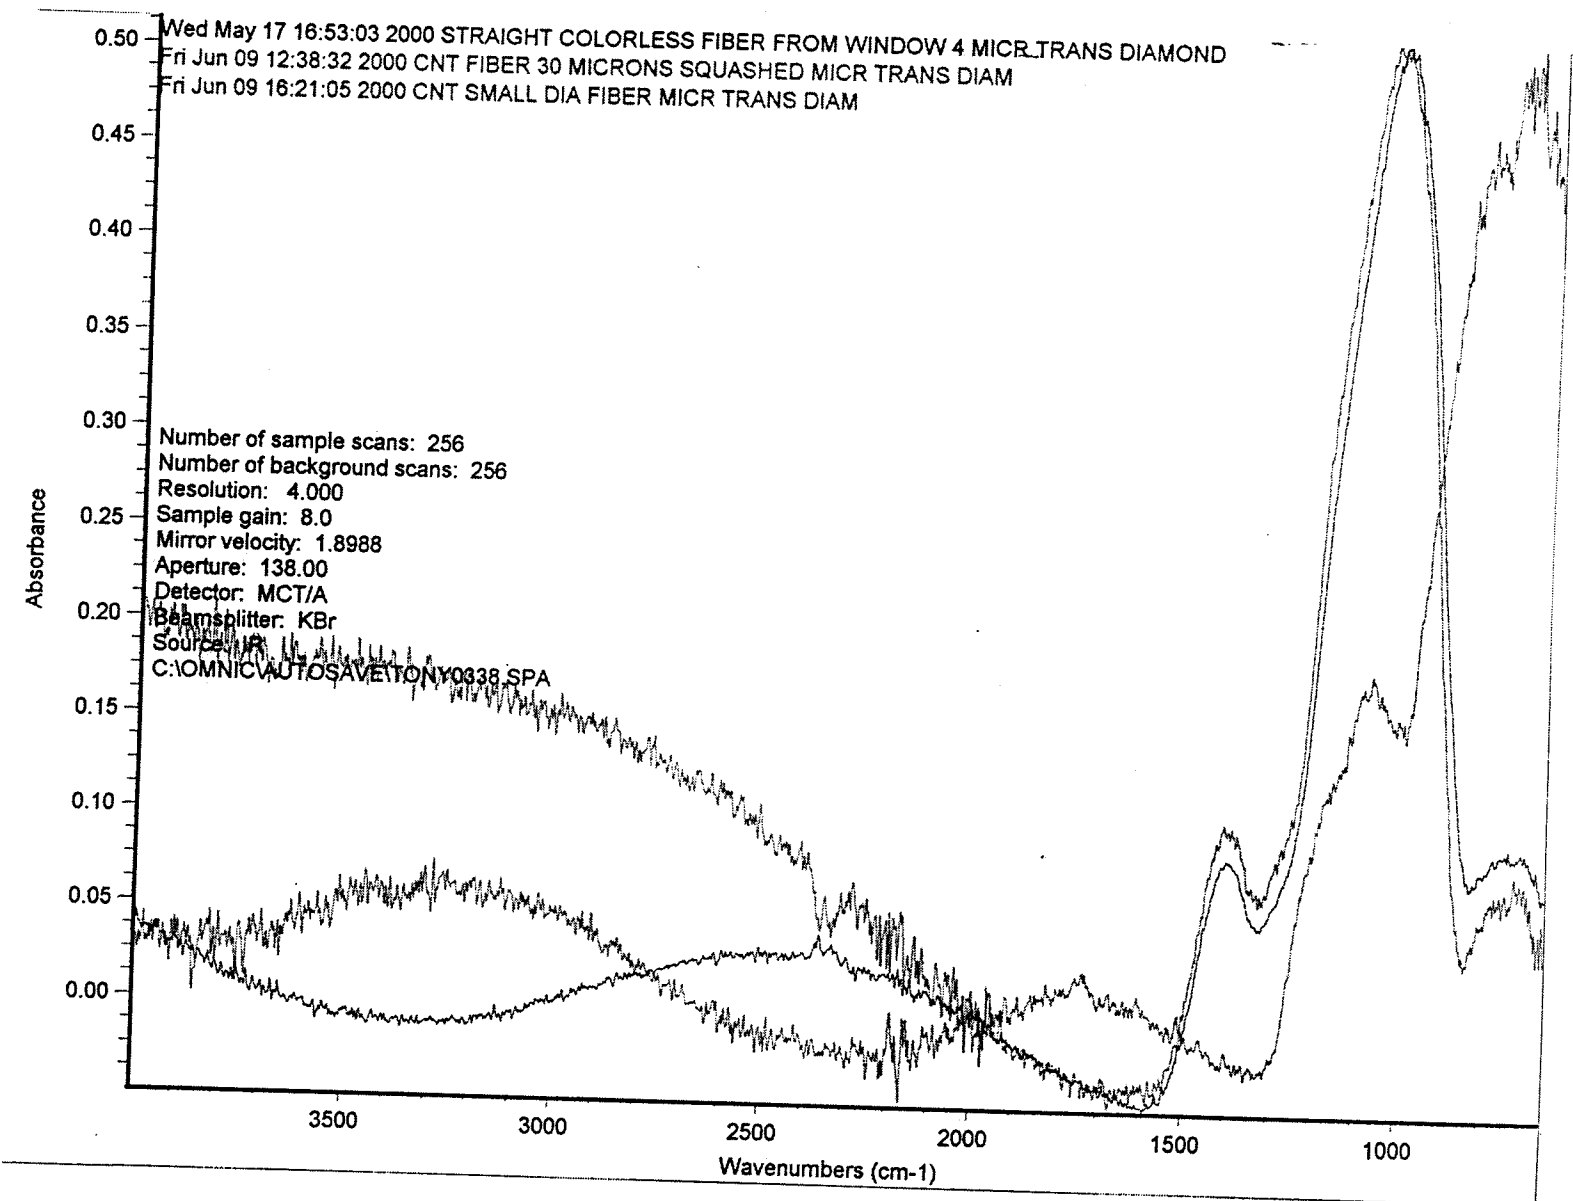
Figure 8. FT-IR Spectra of fiber M from window 4 and the large and small diameter reinforcement fibers found in the CNT material.

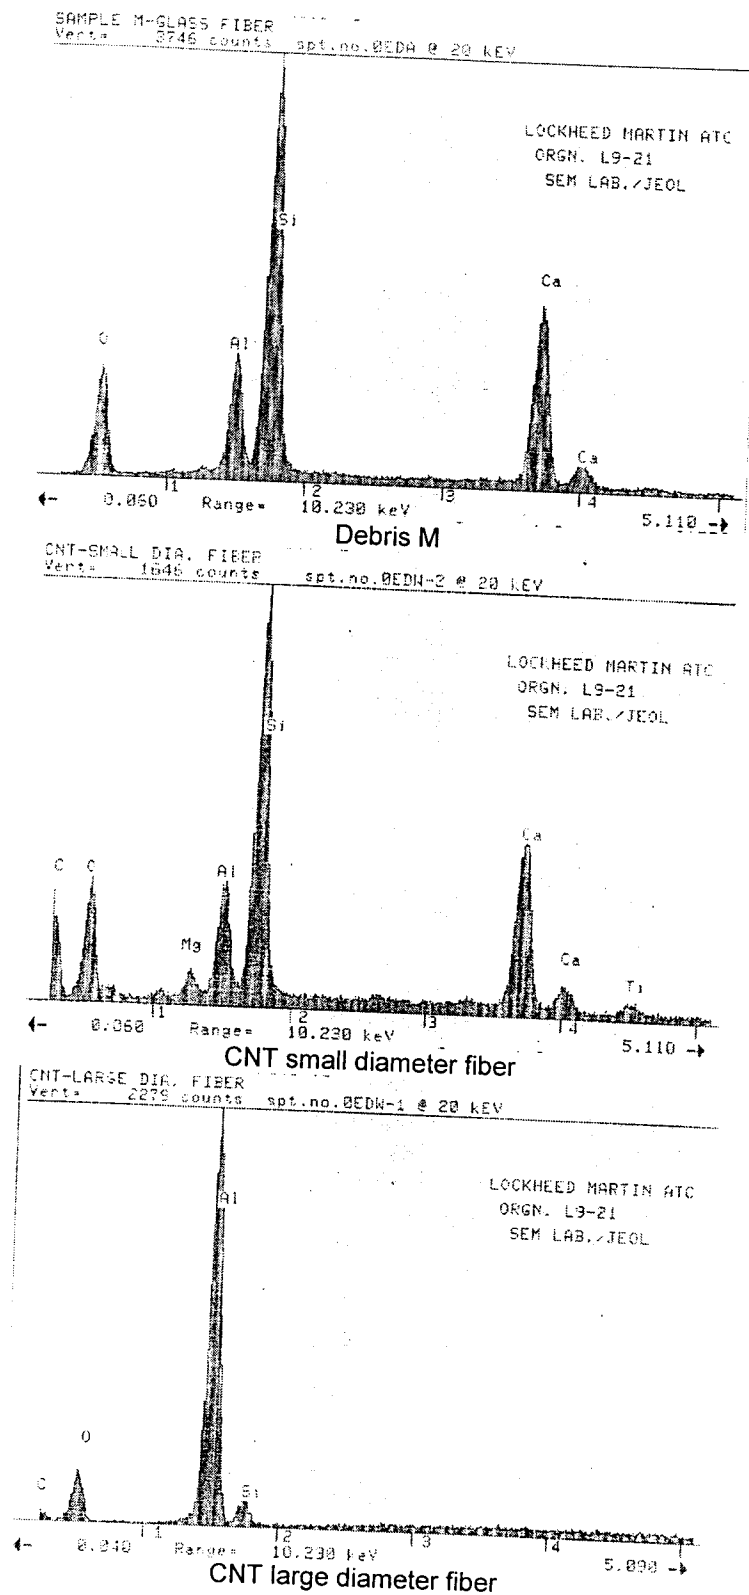
The straight, clear fiber M (301) was identified as a glass, containing oxygen, silicon, aluminum, calcium, and small amounts of magnesium and sodium. These elements are probably in the form of a complex oxide, which is typical for a glass. Representative cured CNT material, which contains reinforcing glass fibers, was examined for comparison to these glassy fibers. It was found that the known CNT material contained two different diameter fibers, and their chemistry varied a little, but both contained alumina and silica. Their FT-IR spectra and that of fiber M are shown in Figure 8. The FT-IR results show the small (340) and large (338) diameter fibers differ from one another, but that fiber M is very similar to that of the small diameter fiber. Photomicrographs of these three fibers are shown in Figure 9 and relative fiber thickness measurements were made at 300X magnification. The larger diameter fiber in the CNT was 0.1560", fiber M was 0.1030" and the smaller diameter CNT fiber was 0.061". EDS elemental analysis is compared in Figure 10.

Figure 10. SEM Elemental analysis comparison of Fiber M and CNT reinforced fibers of different diameters.

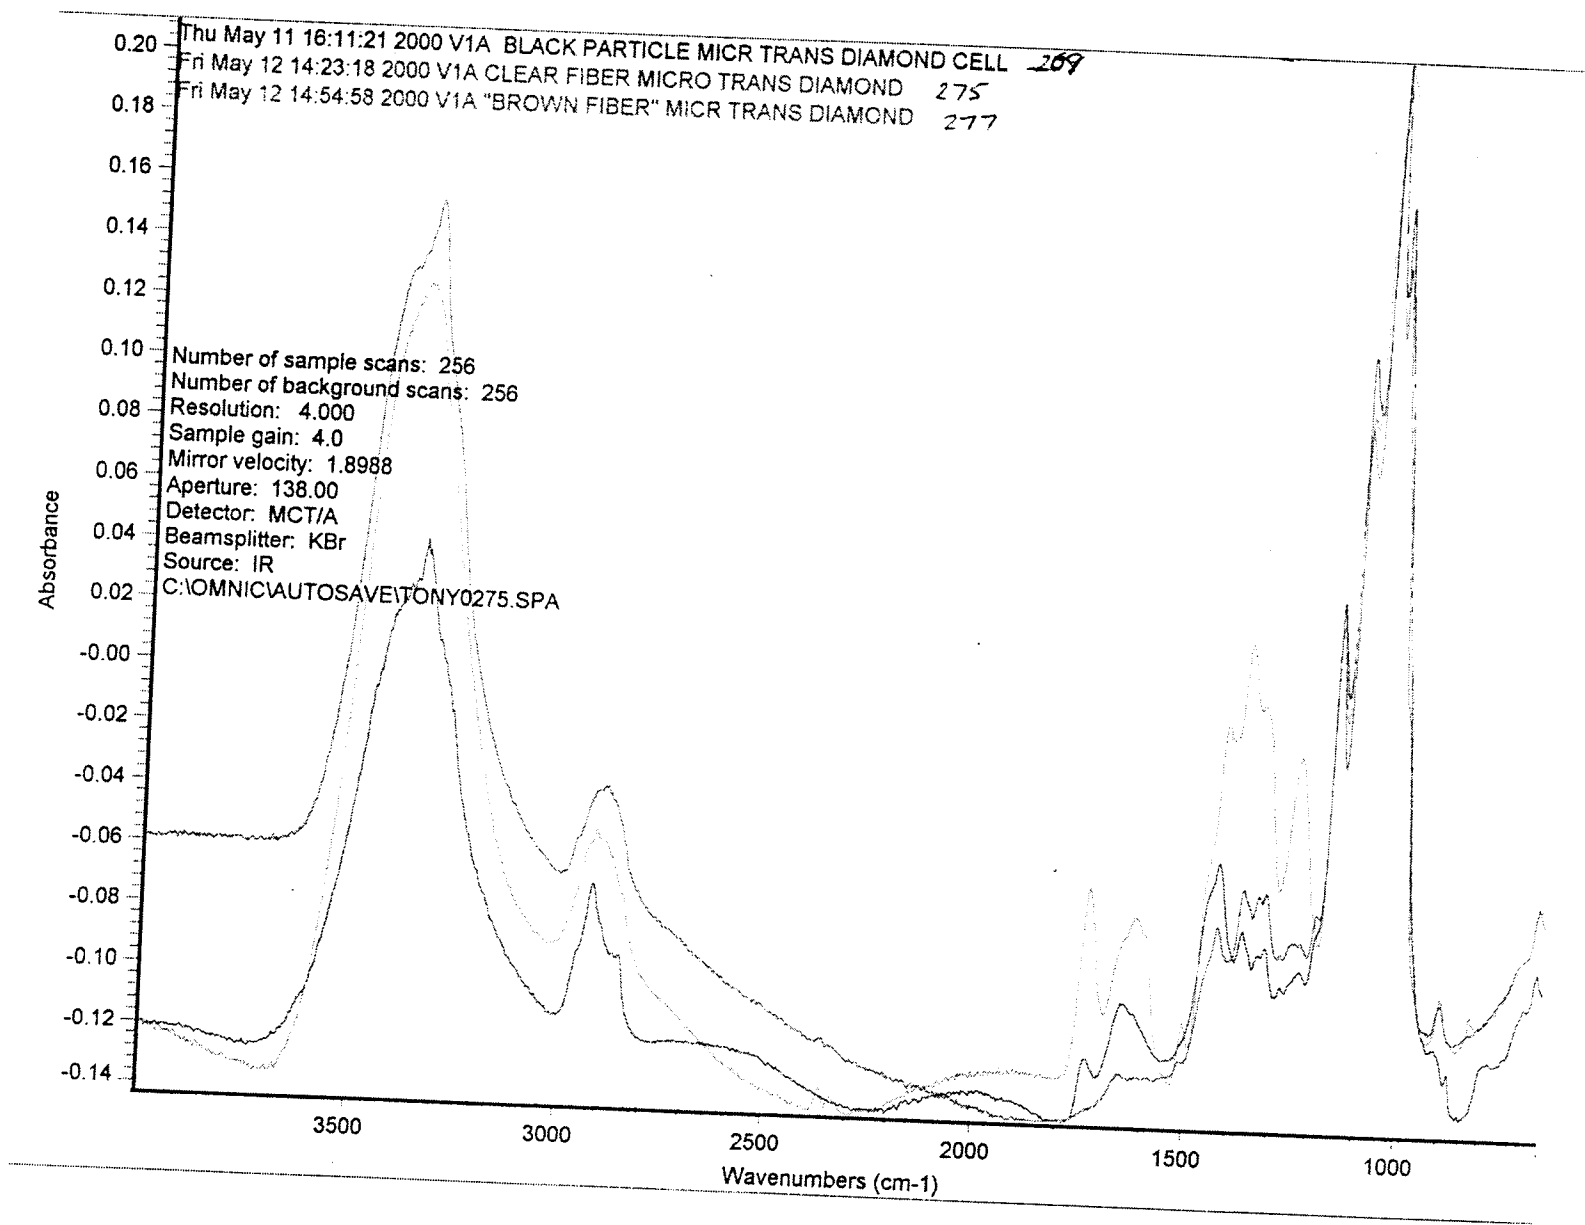
Several vent valve 1A (V1A) particles (269, 277 and 275) were identified as cellulose material and the FT-IR spectra are compared in Figure 11. There are close comparisons of these three particle spectral lines and that of Misc E but not to the Millipore filter.

Figure 11. FT-IR Spectra of vent valve 1A (V1A) particles that were identified as cellulose material.

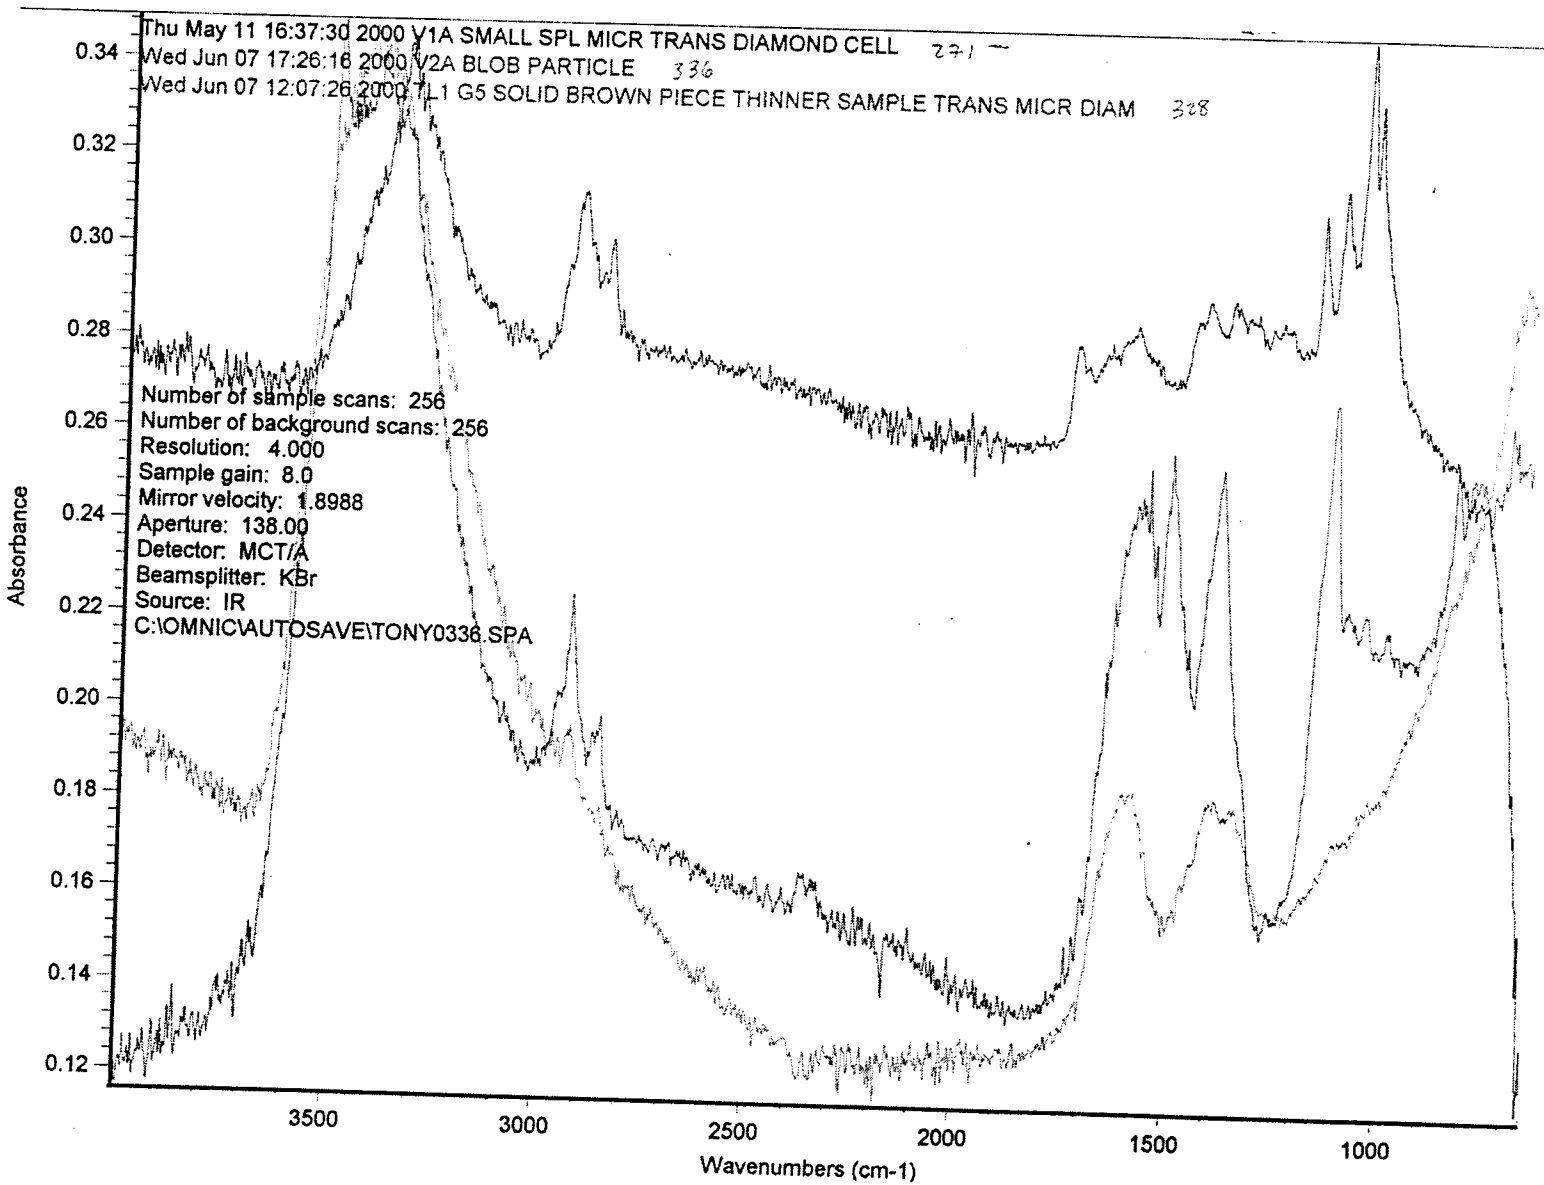
There were several organic debris particles found in the vent valves (V1A and V2A) and a tape-lift particle (TL1 G5) that could not be matched with known materials in the LMSSC, Sunnyvale Operations FT-IR search library. These spectra are compared in Figure 12 but there were no identical matches. There are comparable broad absorption peaks from 3100 to 3600  $\text{cm}^{-1}$ , which are indicative of amine (N-H) or hydroxyl (O-H) organic groups.

Figure 12. FT-IR Spectra comparisons of three debris materials that could not be identified.

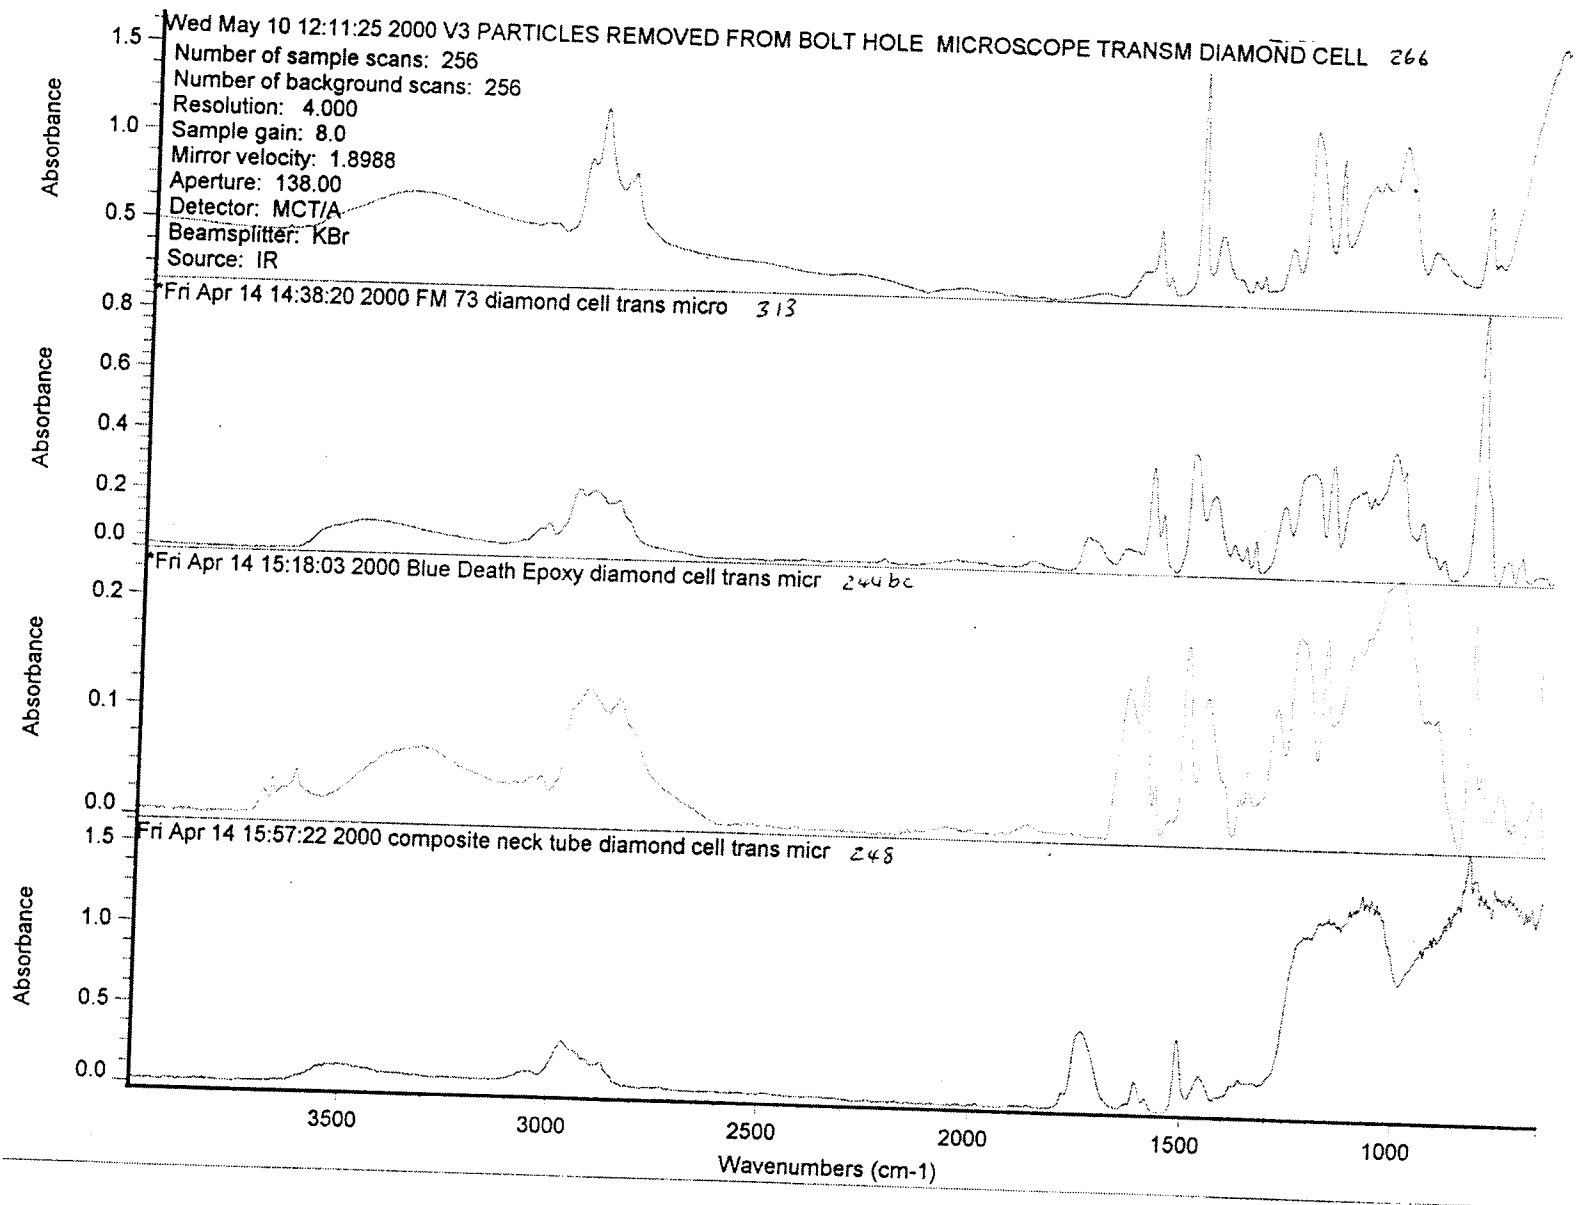
Particles in V3 (266) and the "blue-fibrous debris mass" removed from Station 200 below window 1 (313) were identified as epoxies. FT-IR comparison showed they were not identical to one another. However, each was then compared to the three known epoxies in the CNT area—binder in the CNT, blue death epoxy, and FM-73. V3 (266) had similar general characteristics of FM-73 as shown in Figure 13. The epoxy found at Station 200 compared very well to that of the CNT binder material as shown in Figure 14.

Figure 13. FT-IR Spectra for V3 (debris around bolt holes at valve body 3) and known epoxies (FM-73, blue death, and CNT) are compared.
