W. W. Hansen Experimental Physics Laboratory  
STANFORD UNIVERSITY  
STANFORD, CALIFORNIA 94305-4085  
GRAVITY PROBE B RELATIVITY MISSION

## GMA VALVE LEAKAGE MITIGATION PLAN

S0701 Rev B

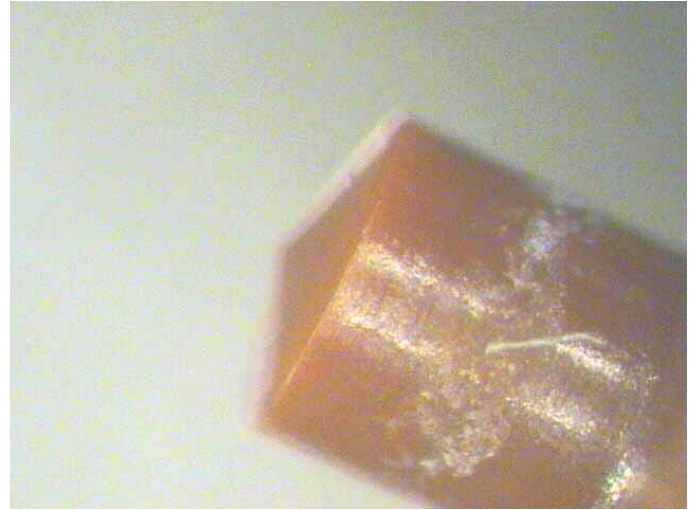
51E265 SN007 Poppet tip showing white residue (aluminum silicate)

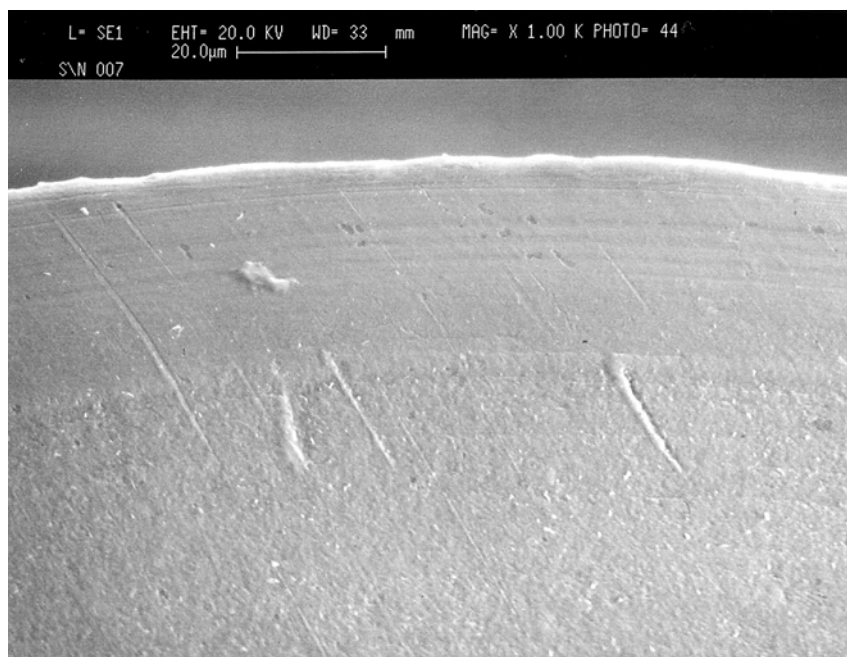
51E265 SN007 Poppet sealing surface viewed with Lockheed Martin SEM. Note scratches.

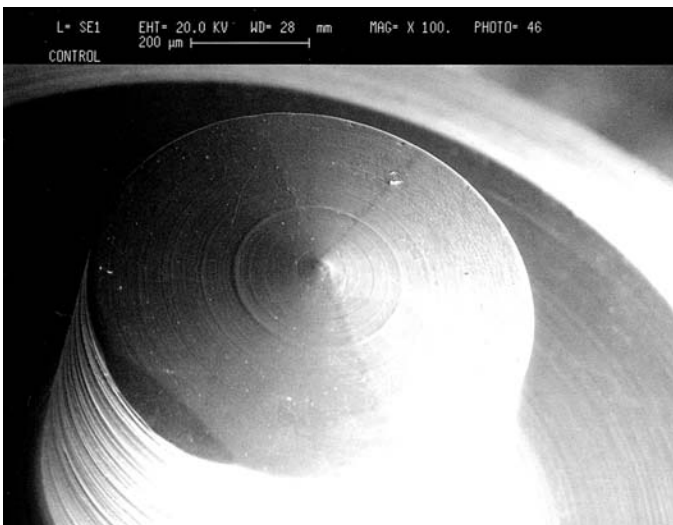
51E2657 Poppet sealing surface viewed with Lockheed Martin SEM. Poppet never installed.

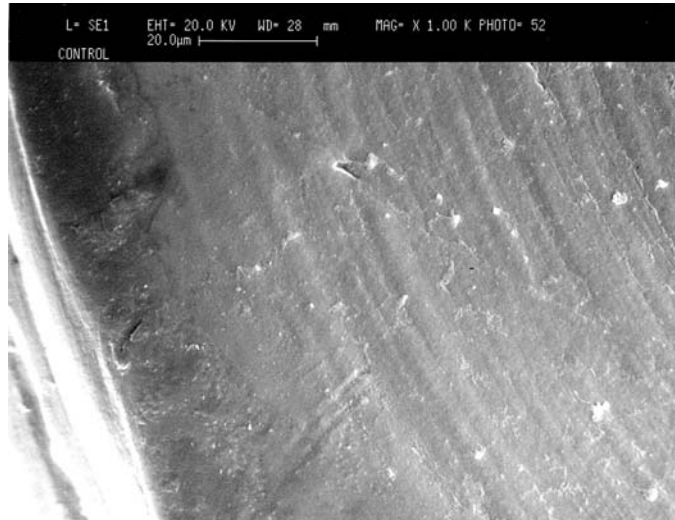
51E265 Poppet sealing surface viewed with Lockheed Martin SEM. Note localized high and low spots and scratches. Poppet never installed.
